**VALUATION REPORT ON PROPERTY NO. 13314-10115  
HA ABIA, MASERU URBAN AREA**

**OWNER: LEETO ANANIAS SEKOCHÉ  
&  
MASERETSE JUSTINA SEKOCHÉ**

**VALUATION OF YOUR PLOT NO.13314-10115**

**HA ABIA- MASERU URBAN AREA**

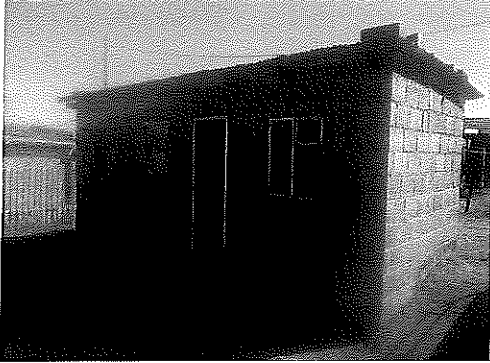
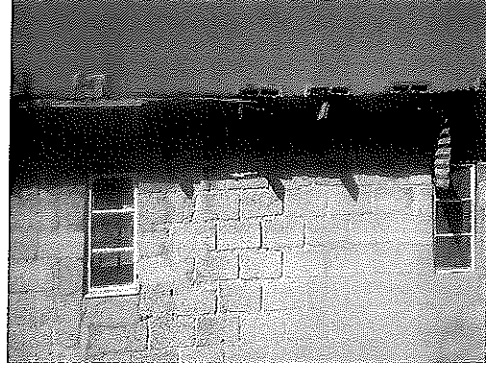
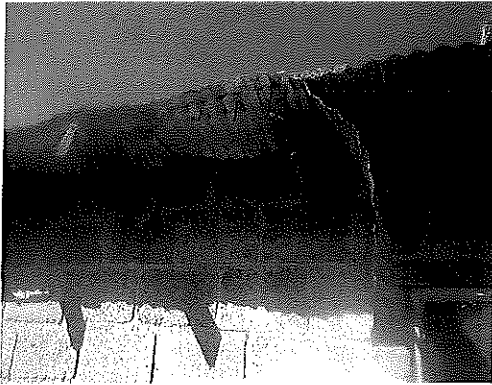
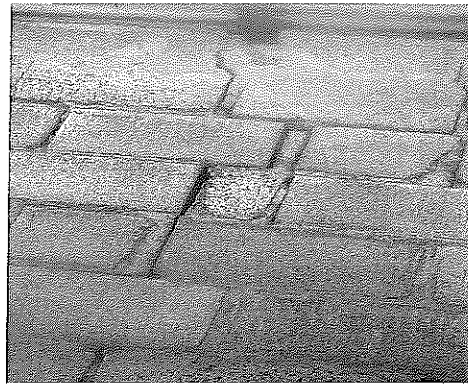
**Defects on the Outbuilding**

**Condition:** It is in a bad condition. Structural wall foundation defects, worn  
trusses broken door locks. The building needs to be demolished it is not  
habitable.
