**LAND ADMINISTRATION AUTHORITY
LAA**

**VALUATION REPORT ON PROPERTY NO. 14231-329
HA PAKI MAZENOD MASERU DISTRICT**

OWNER: MARELEBOHILE SUZAN MOHAPI

**CONSULTING VALUERS: OXBOW LAND & PROPERTY
CONSULTANTS (PTY) LTD**

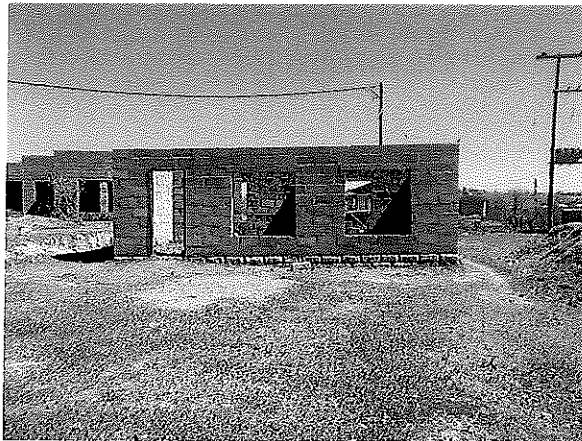
- 8.0 **Description of improvements:**
 - 8.1 Built of Coro face brick wall structure. Internal walls are of concrete block .This consists of 2 rooms with bare internal walls & foundational floor beds in all rooms. Roofing to be done.
Please note that the building is not complete.
Condition: Structure wall defect on the above window lintel
