**VALUATION REPORT ON PROPERTY No.30084 -415  
HA KAMOHO, BOTHA-BOTHE URBAN AREA**

**OWNER: NEO GLADYS MOHLOAI**

**CONSULTING VALUERS: OXBOW LAND & PROPERTY  
CONSULTANTS (PTY) LTD**

### **VALUATION OF YOUR PLOT No.30084-415 HA KAMOHO– BOTHA-BUTHE URBAN AREA**

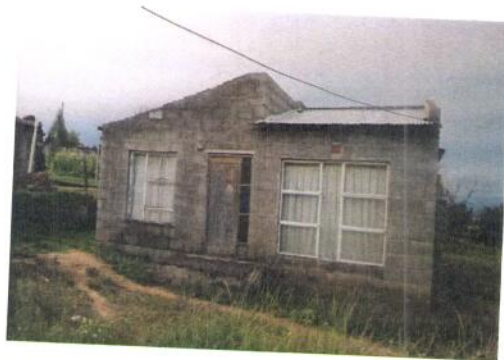
**Accommodation**  
**Lounge, Kitchen, Passage, Bedroom 1 & 2**  
**Condition:** Roof leakages Broken windows & wooden door panels walls. floor cracks and plaster and paint scrapings most of the rooms.
